CALSPAN ON-SITE AIR BAG/CHILD FATALITY INVESTIGATION

CALSPAN CASE NO. 96-15

VEHICLE - 1995 MAZDA PROTÉGÉ'

LOCATION - OHIO

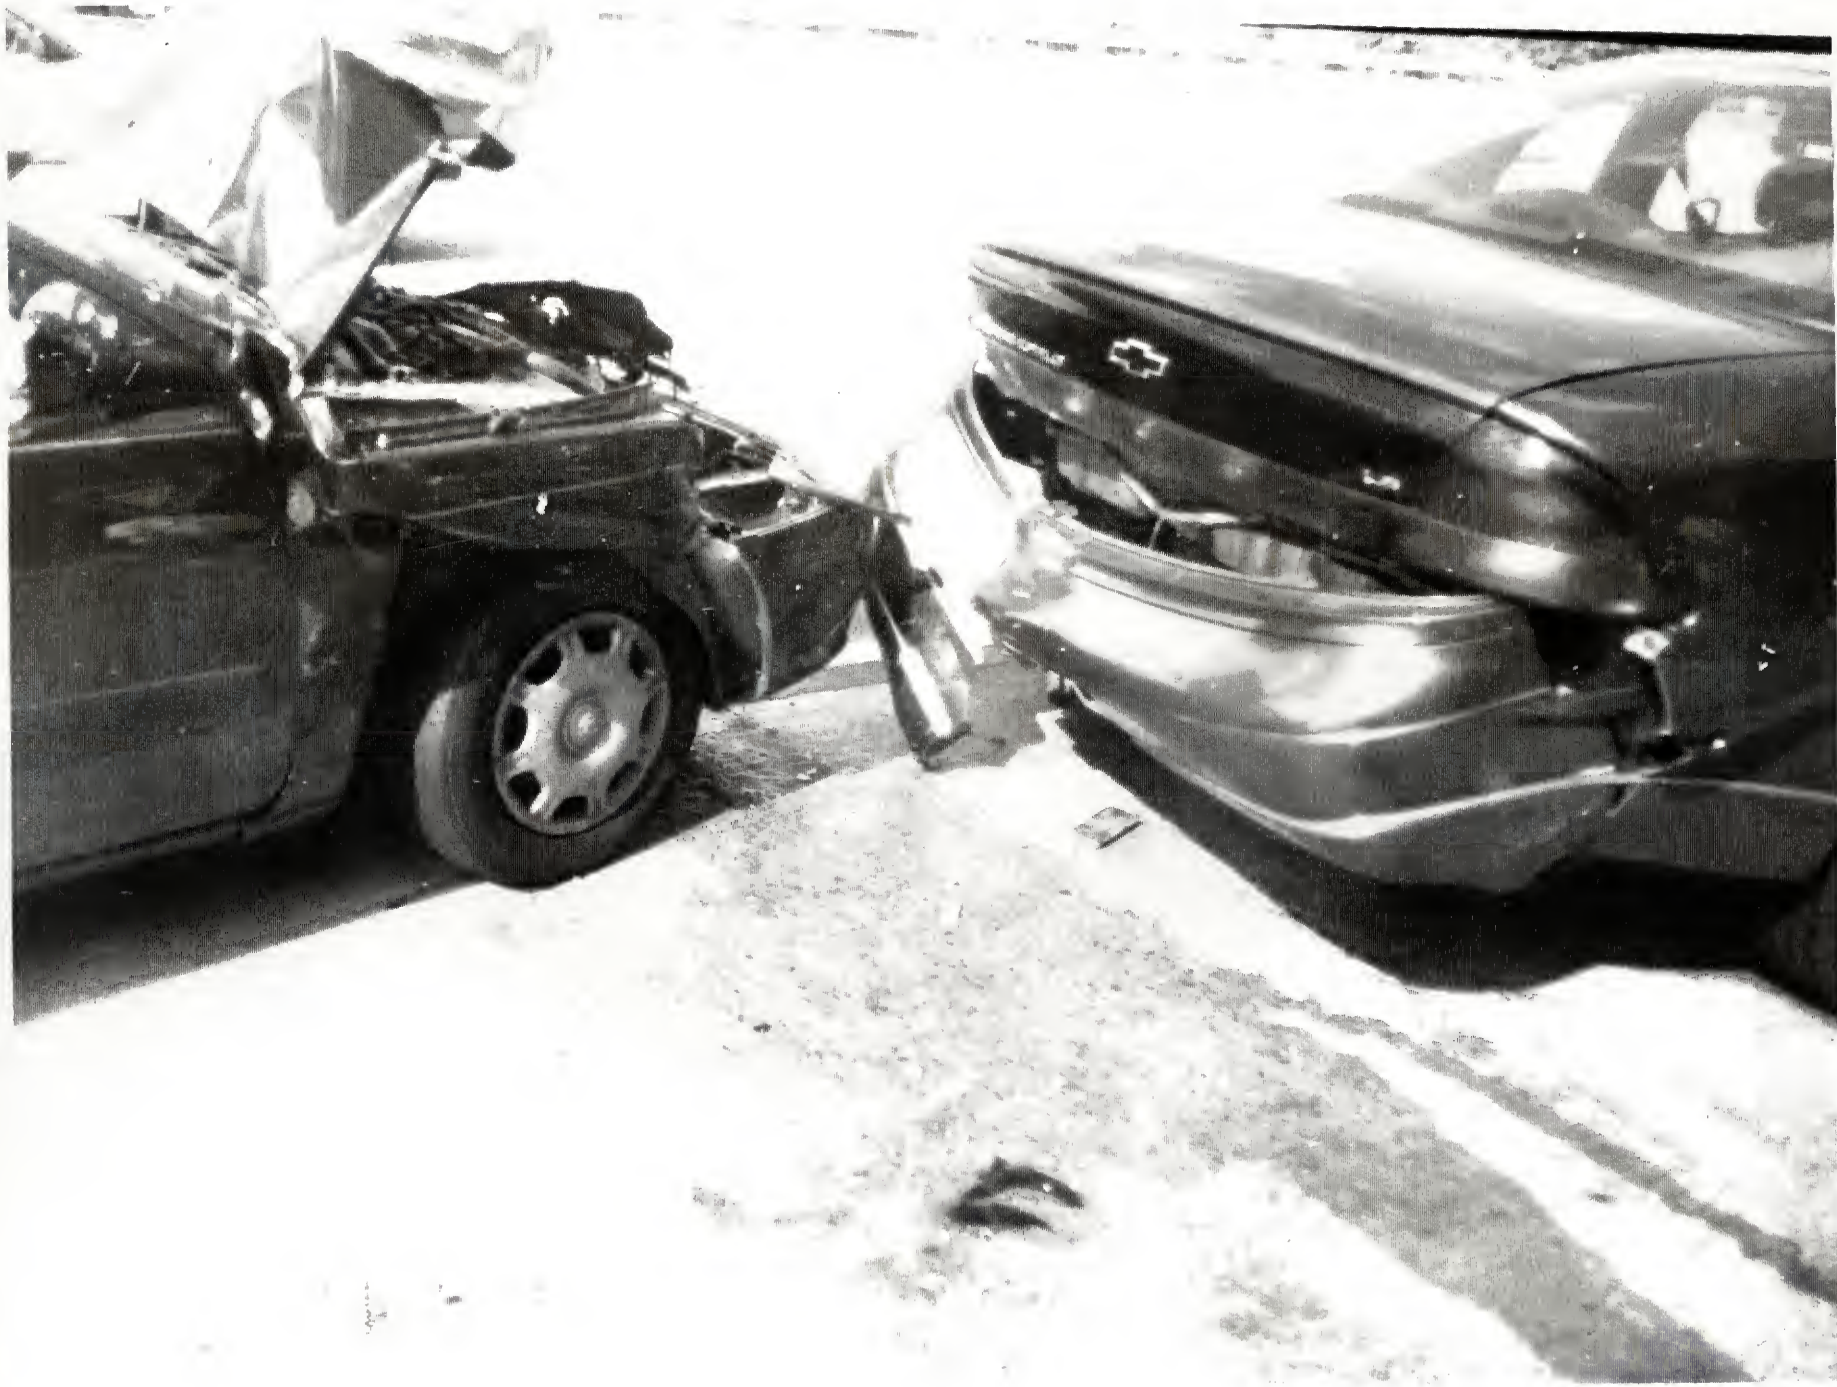
4. Impact damage of the 1995 Mazda Protégé and the 1995 Chevrolet Monte Carlo.

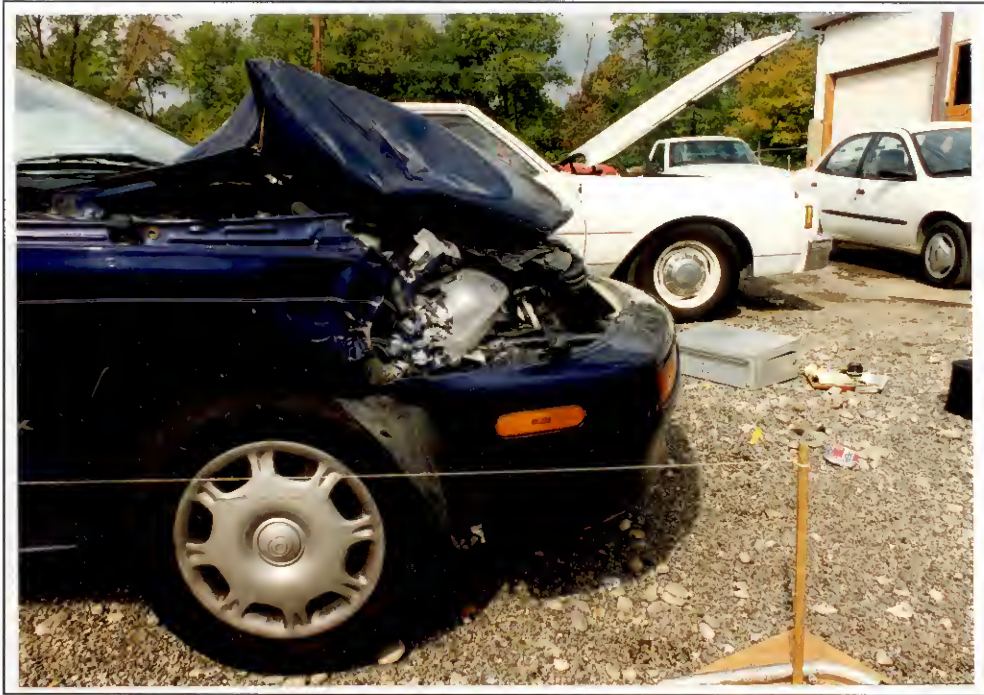
13. Close-up view of the right front damage.

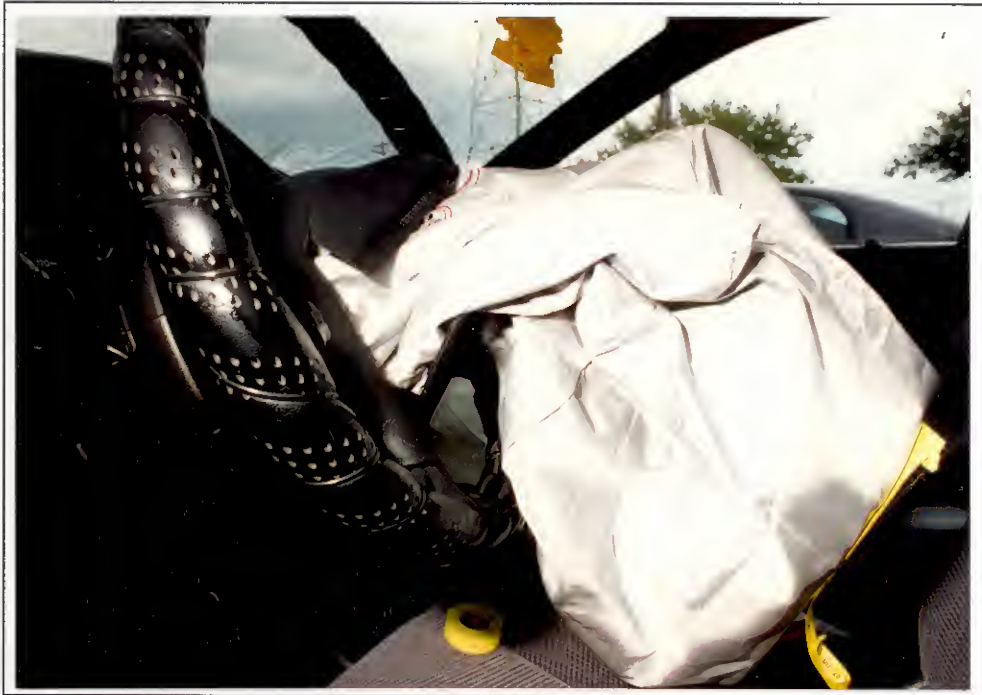
21. View of the deployed air bag and cover flaps.

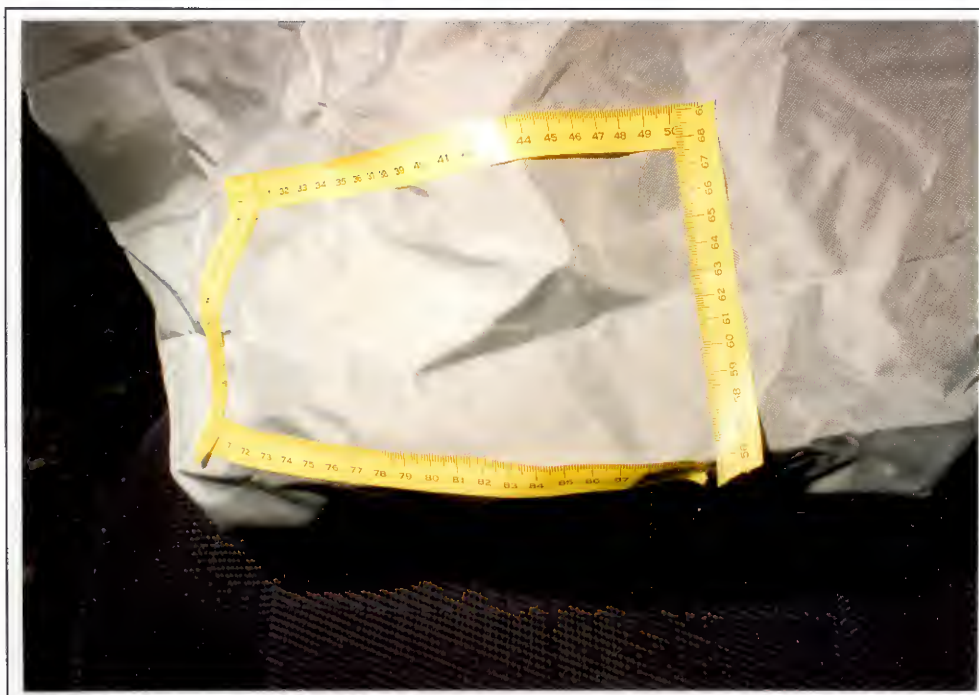
26. Close-up view of a tissue transfer on the lower left quadrant of the air bag.

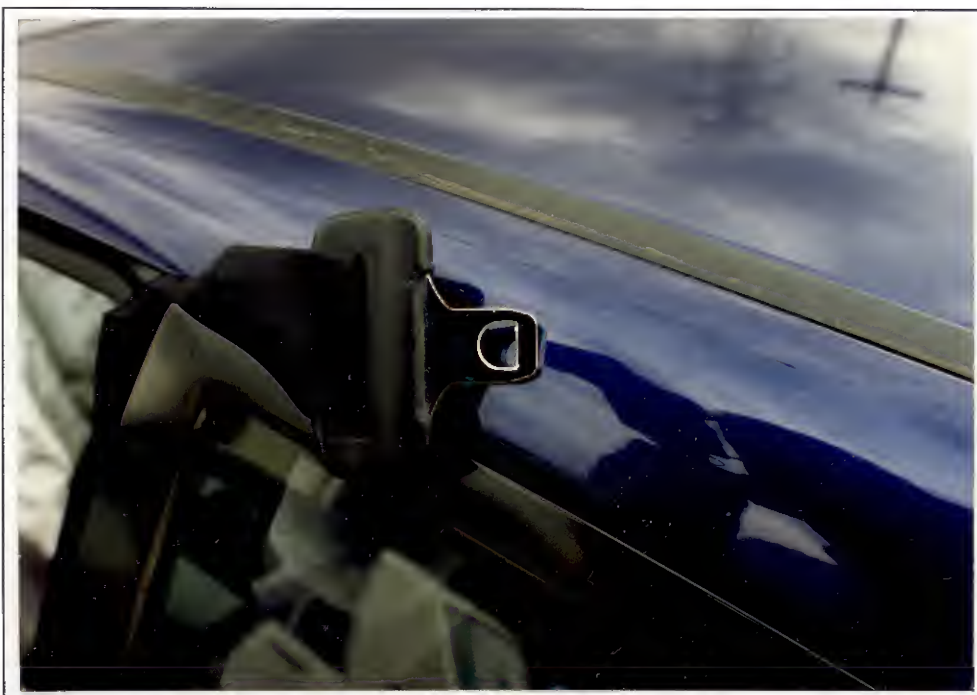
29. View of the left front latch plate depicting infrequent use.

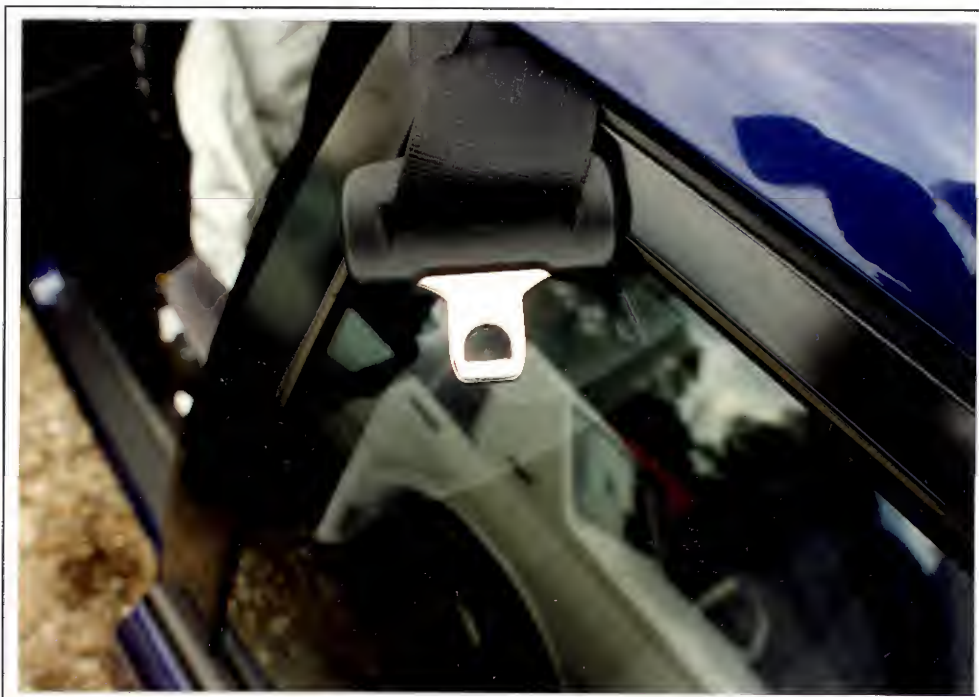
30. View of the left front latch plate (opposite side) depicting infrequent use.

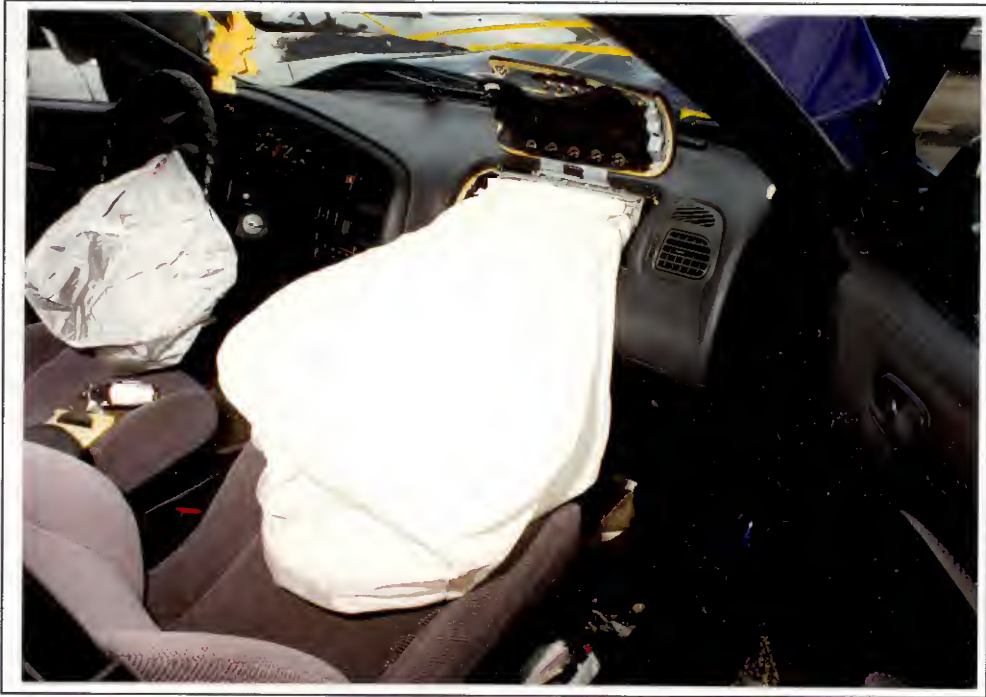
36. View of the right front interior and deployed passenger air bag.

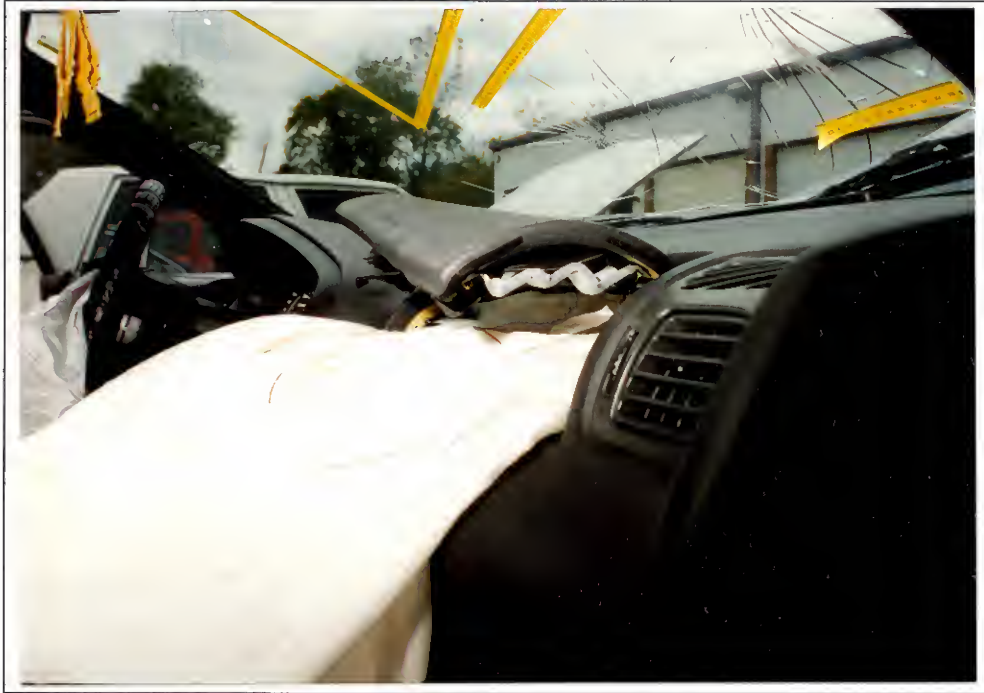
38. Angular view of the deployed passenger air bag and module cover.

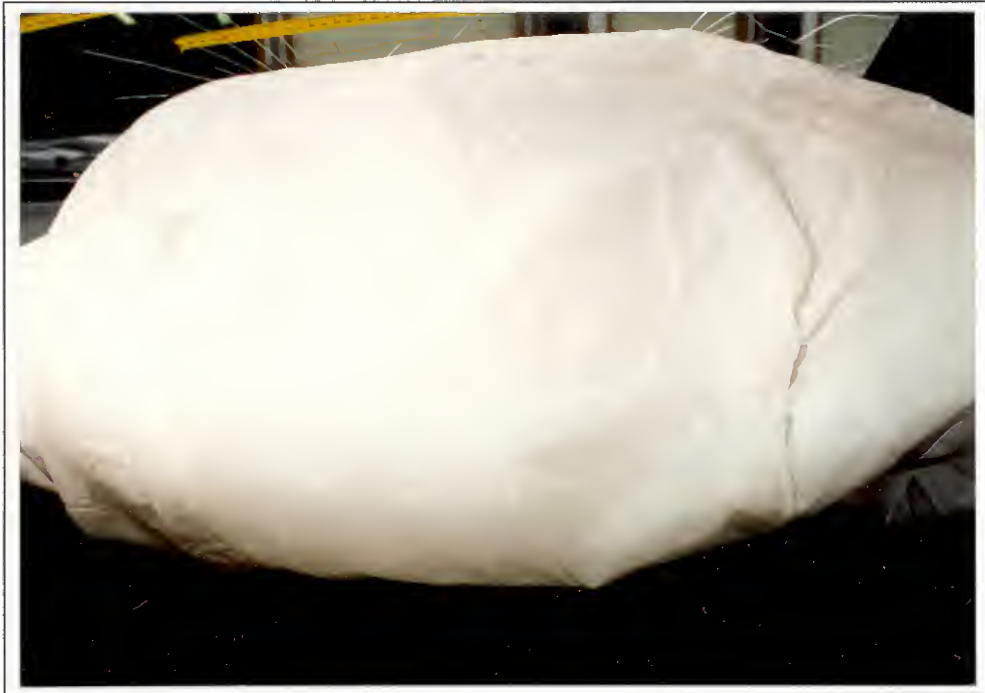
40. View of transfers on the face of the deployed passenger air bag.

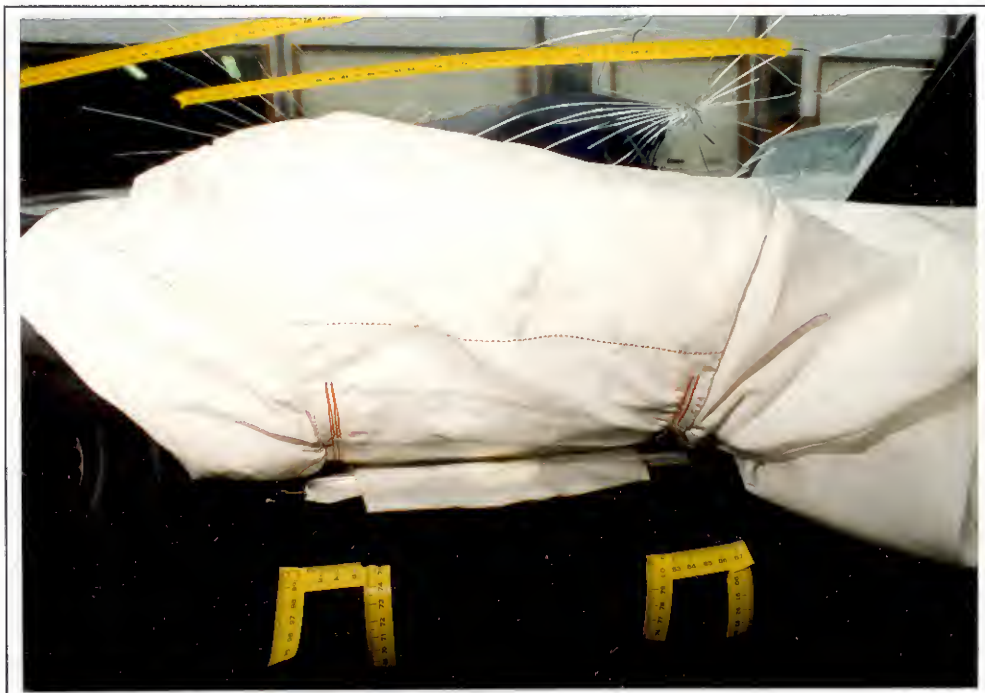
41. View of the blue/green transfers on the lower surface of the deployed passenger air bag.

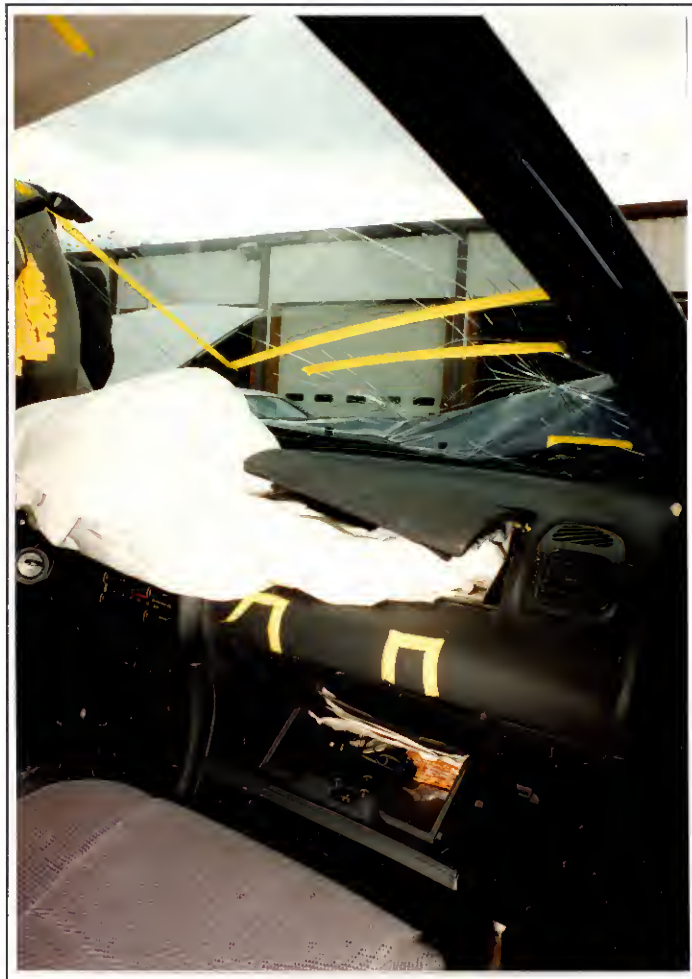
43. Close-up view of the right front interior and contacts.

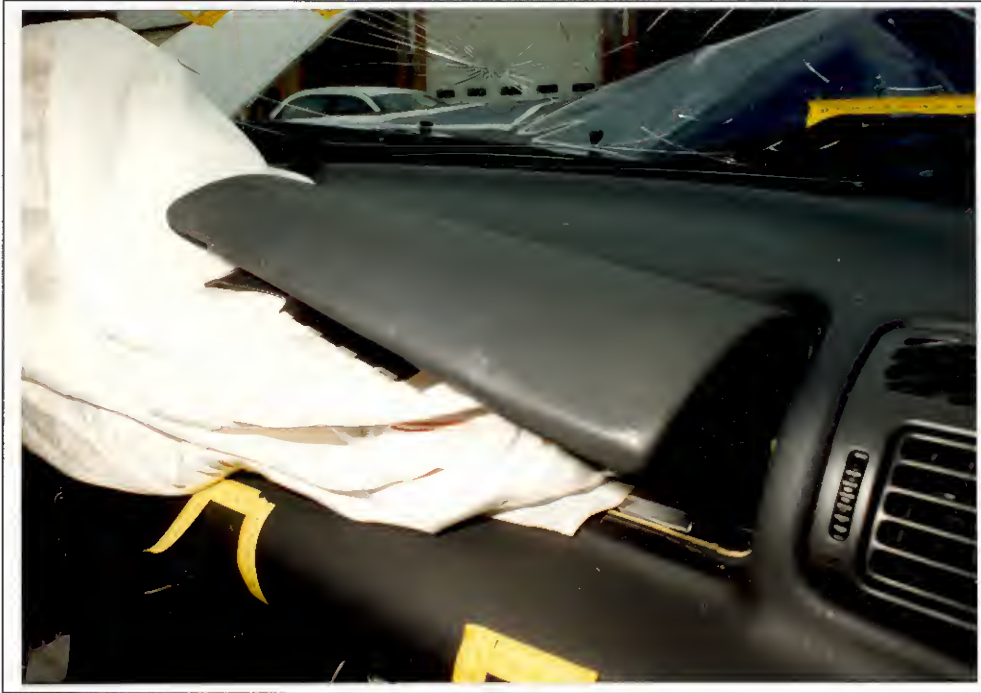
46. View of the deformed passenger side air bag module cover.

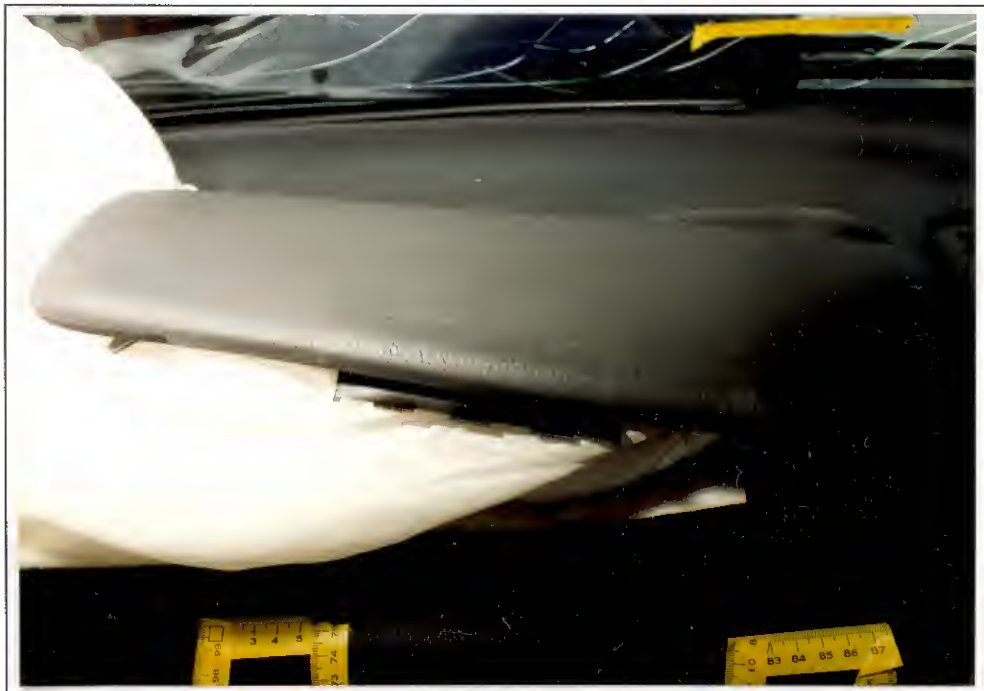
47. View of white vinyl transfer marks on the leading edge of the module cover.

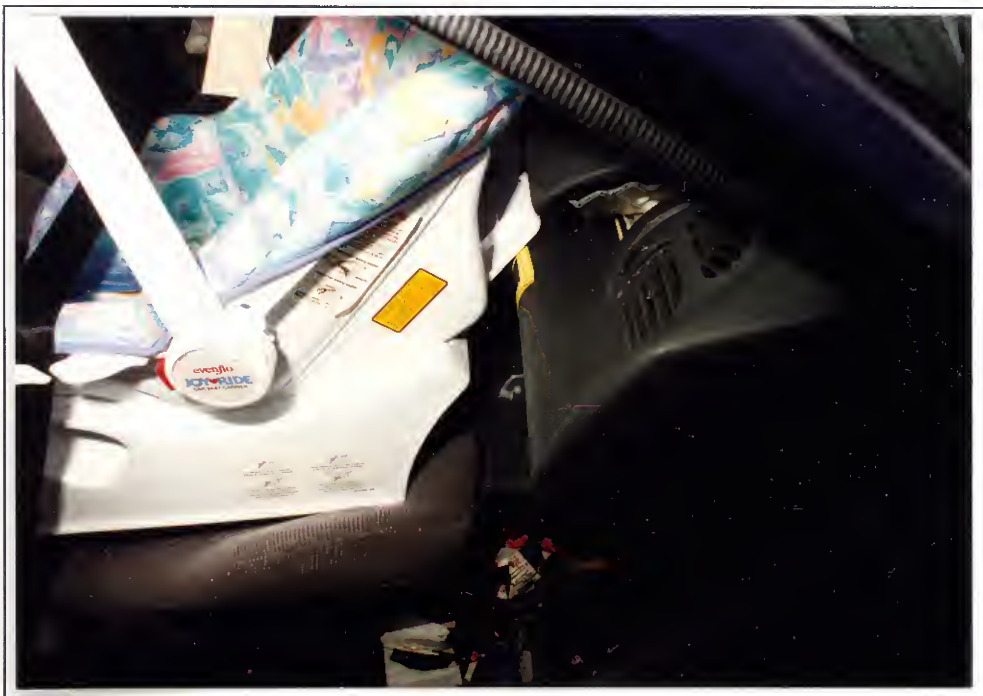
During the pre-impact braking phase of the crash, the child restraint moved forward with respect to the vehicle contacting the leading edge of the instrument panel. This placed the upper aspect of the child restraint shell over the top of the passenger side air bag module cover flap. Upon impact and subsequent air bag deployment, the module cover flap rotated upward contacting the upper rear aspect of the shell of the child restraint. This contact and the expanding passenger side air bag would have caused the restraint to rotate violently rearward about the seat back/seat cushion juncture. This rotation, in-turn, would accelerate the infant occupant forward with respect to the child restraint. The contact from the mid-mount passenger air bag module cover flap and the deploying air bag against the shell of the restraint, in combination with the acceleration of the restraint, resulted in the occupant's skull fracture with brain swelling.

65. View of the relationship between the child restraint and the right side instrument panel (IP).

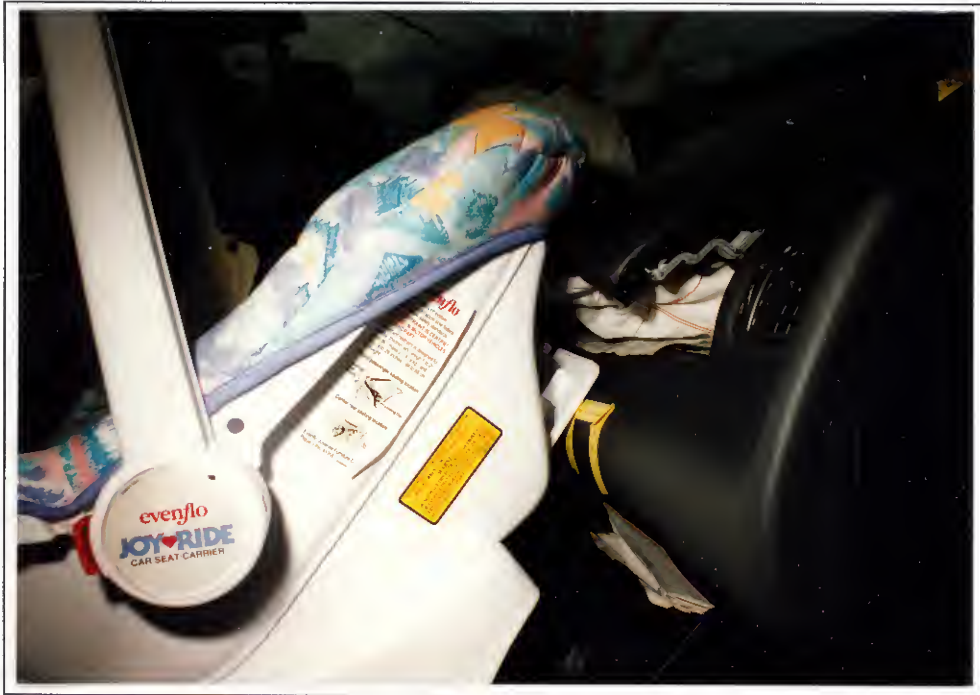
66. View of the relationship between the leading edge of the module cover and the back of the child restraint.

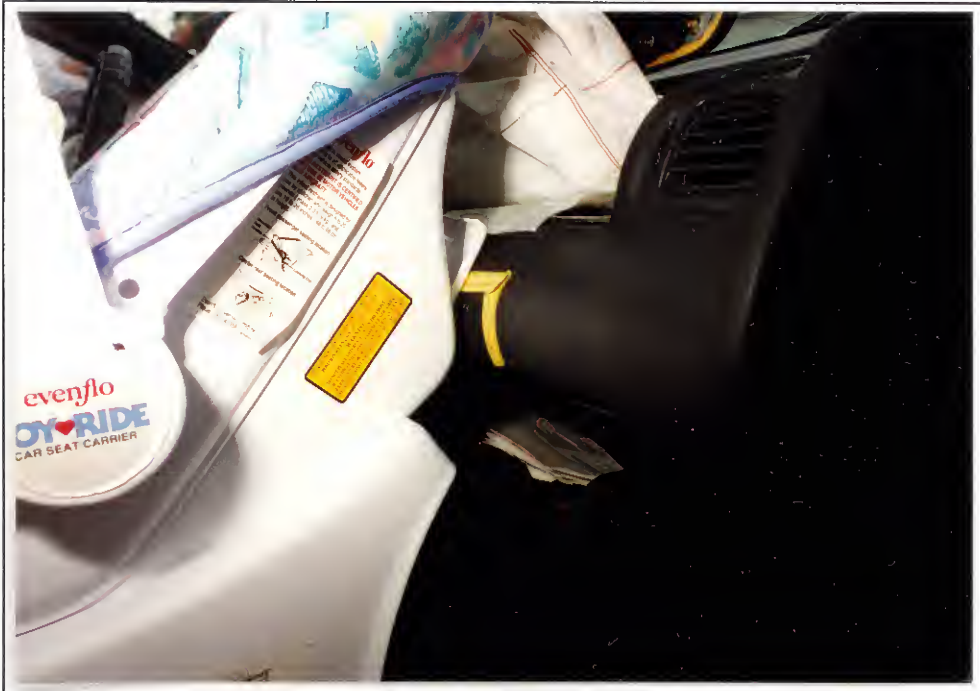
67. View of the relationship between the contacts on the leading edge of the IP and the back of the child restraint.

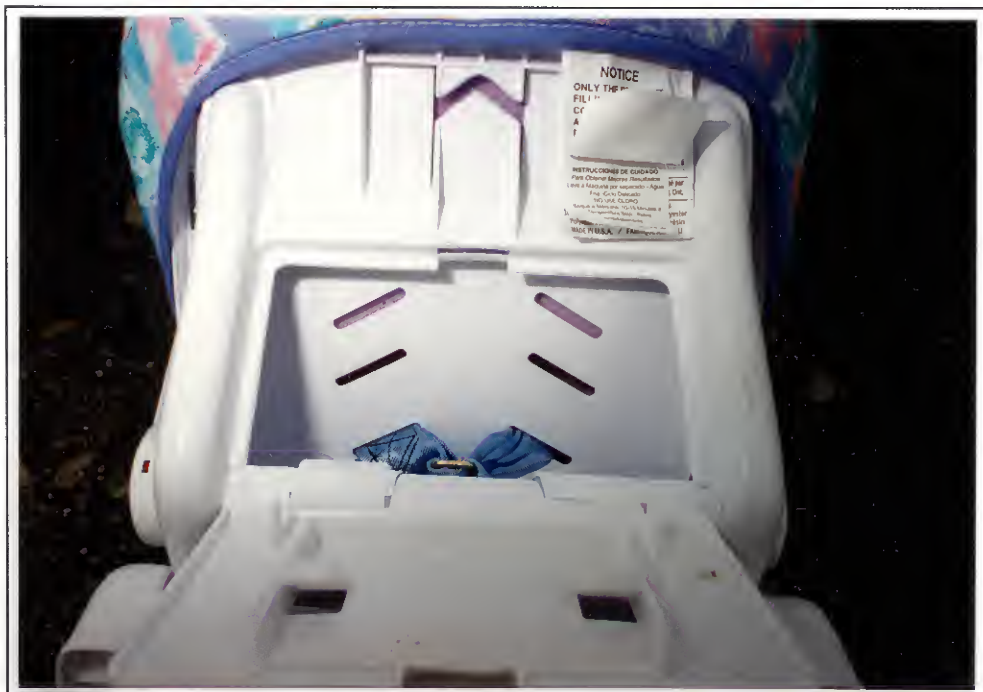
84. Overall view of the back of child restraint with the rear compartment open depicting the shoulder strap routing

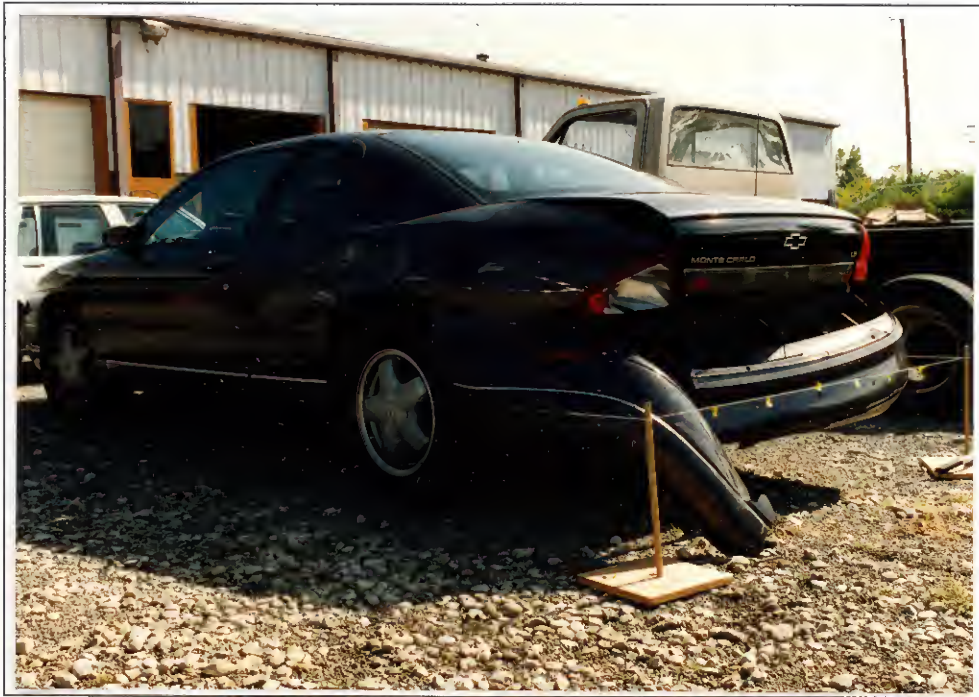
94. Left rear three-quarter view of Vehicle 2.

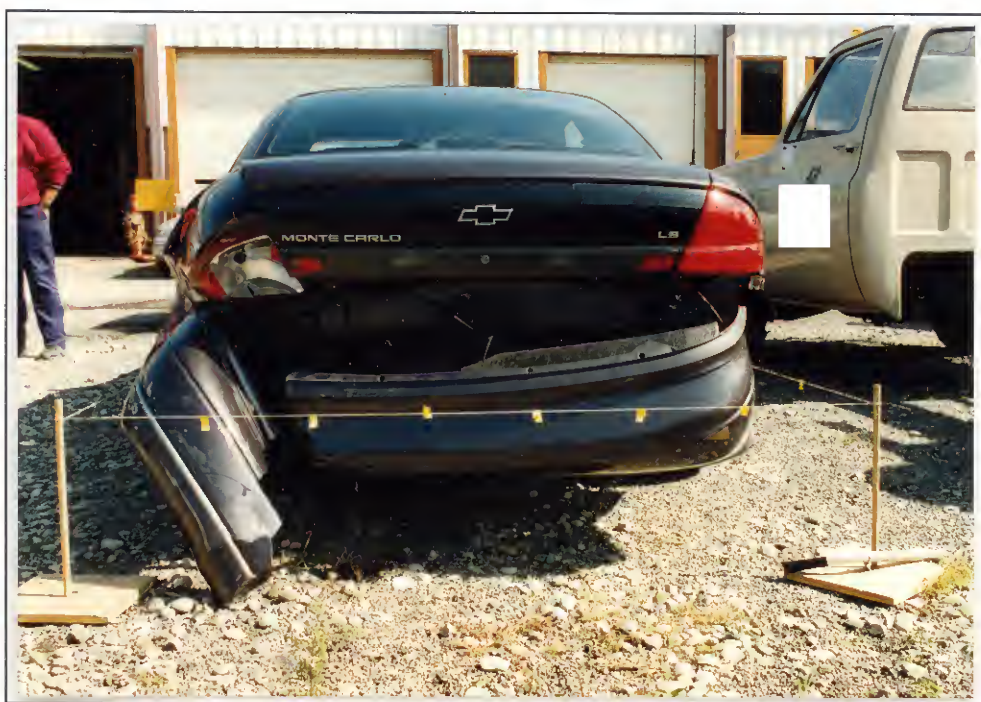
98. Rear view of Vehicle 2.

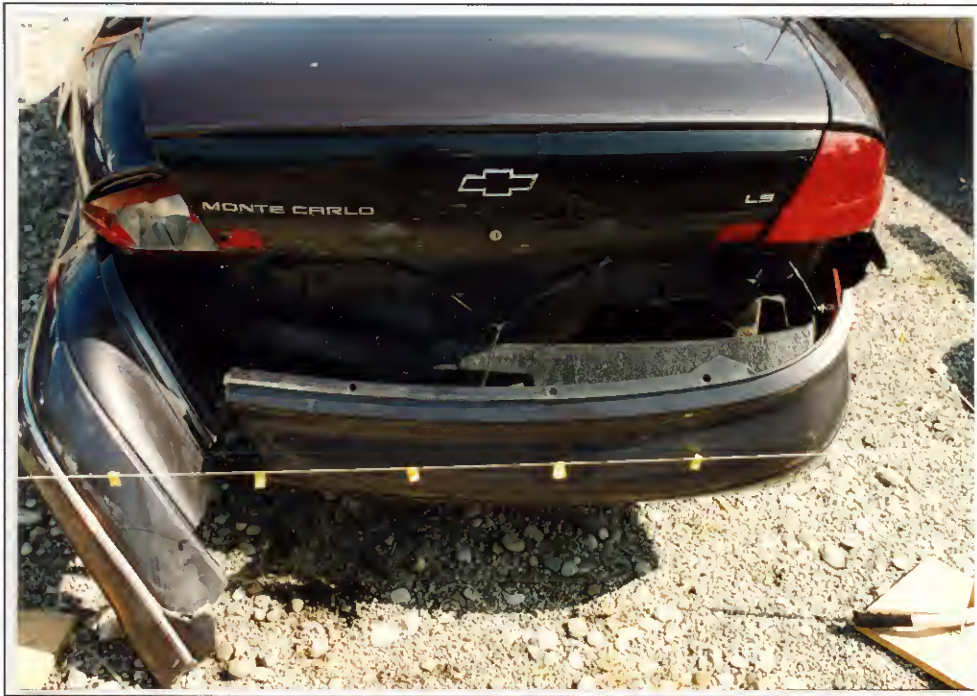
99. View of the rear bumper deformation.

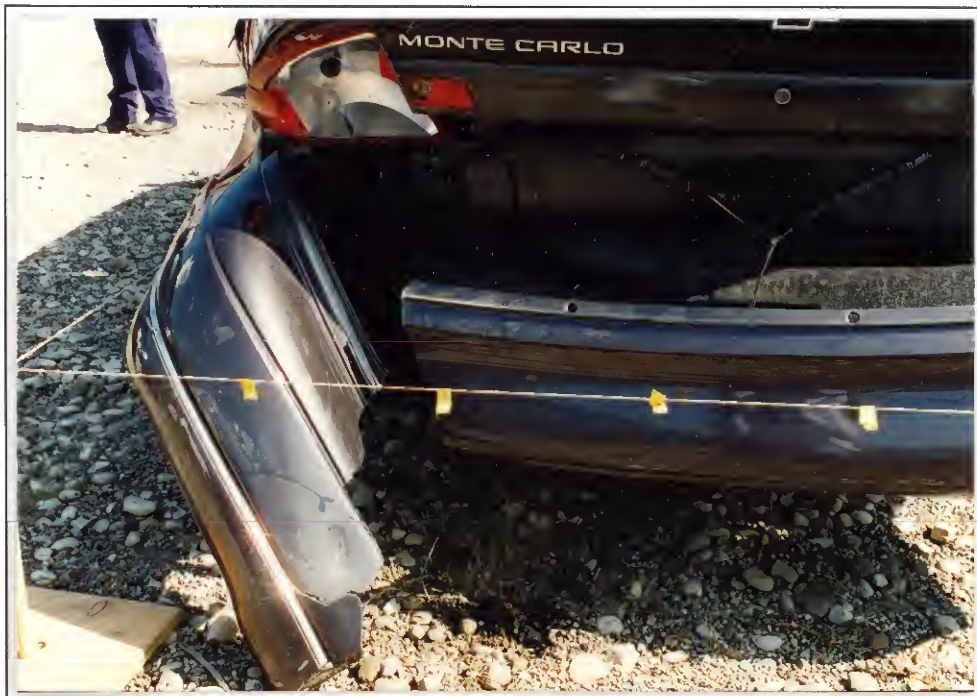
100. View of the left half of the rear bumper.

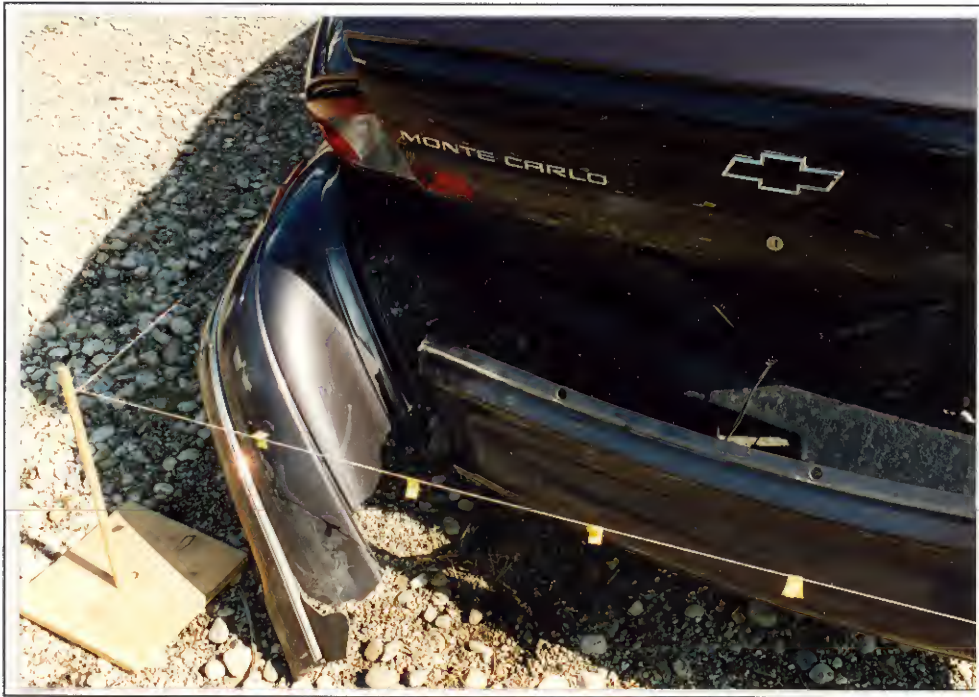
101. Close-up view of the direct contact.

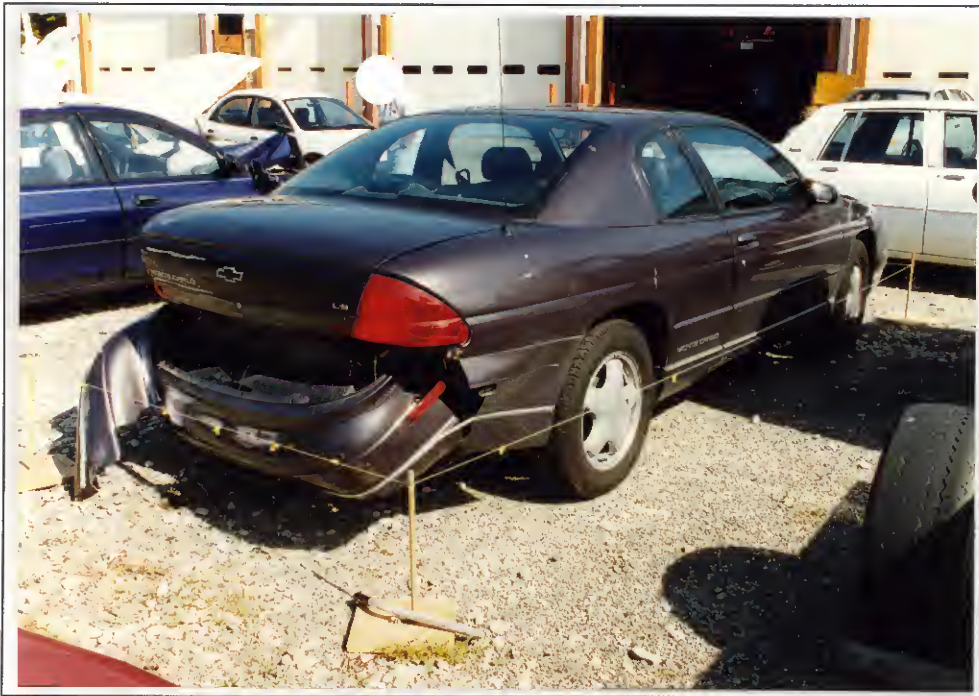
102. Right rear three-quarter view of Vehicle 2.

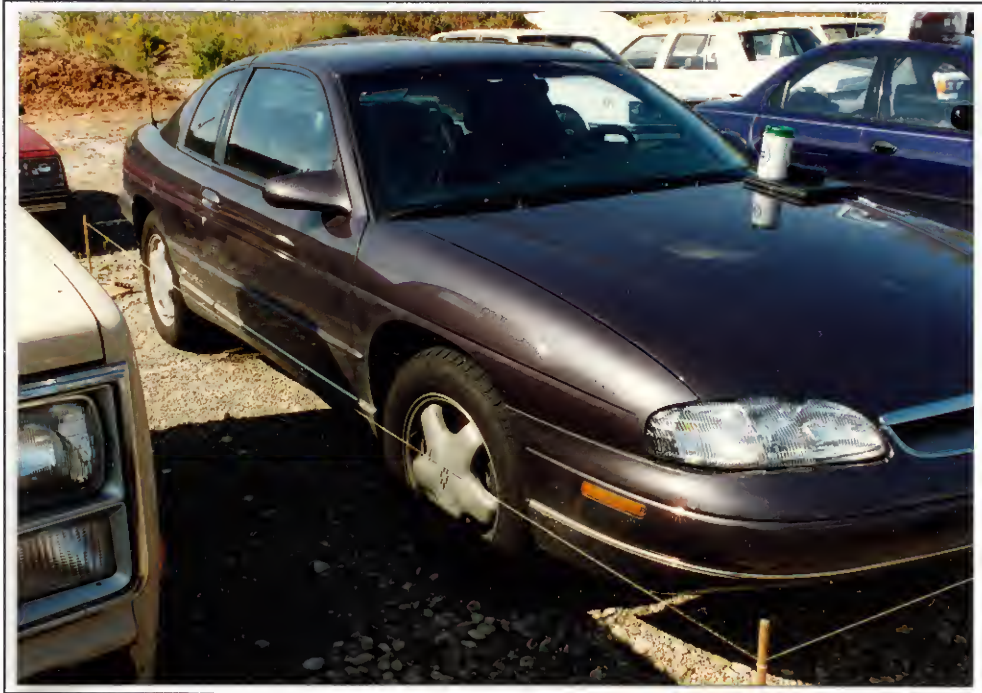
104. Right side view of Vehicle 2.

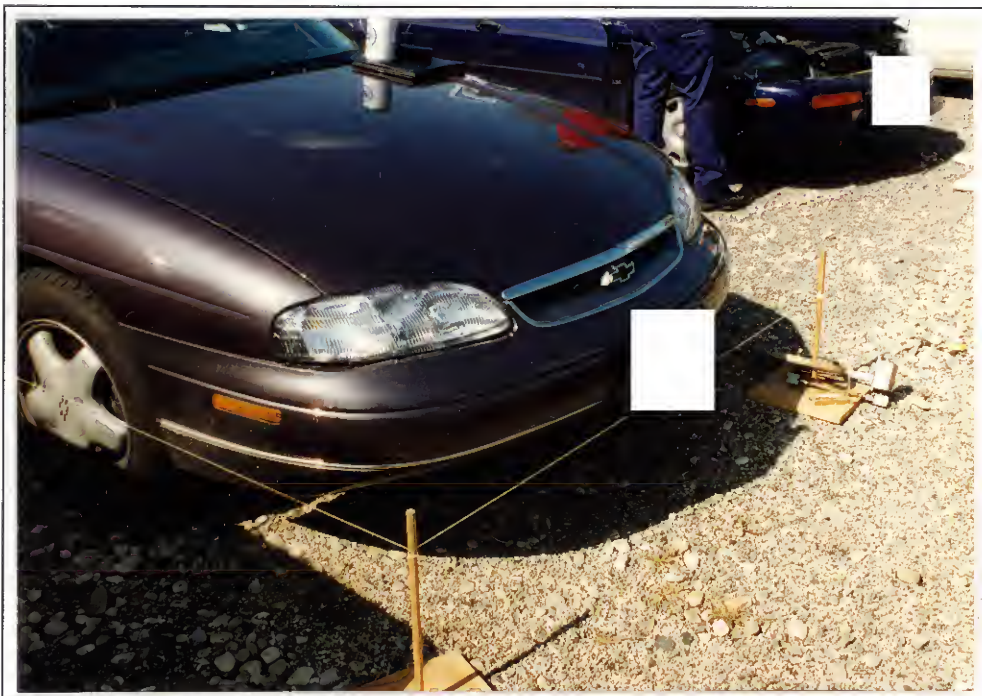
105. Right front view of forward third of Vehicle 2.
